Advances in Civil Engineering and Building Materials IV

Reliability of visual inspection, an example of timber structure in Valencia, Spain

M. Diodato, C. Mileto & F. Vegas López-Manzanares

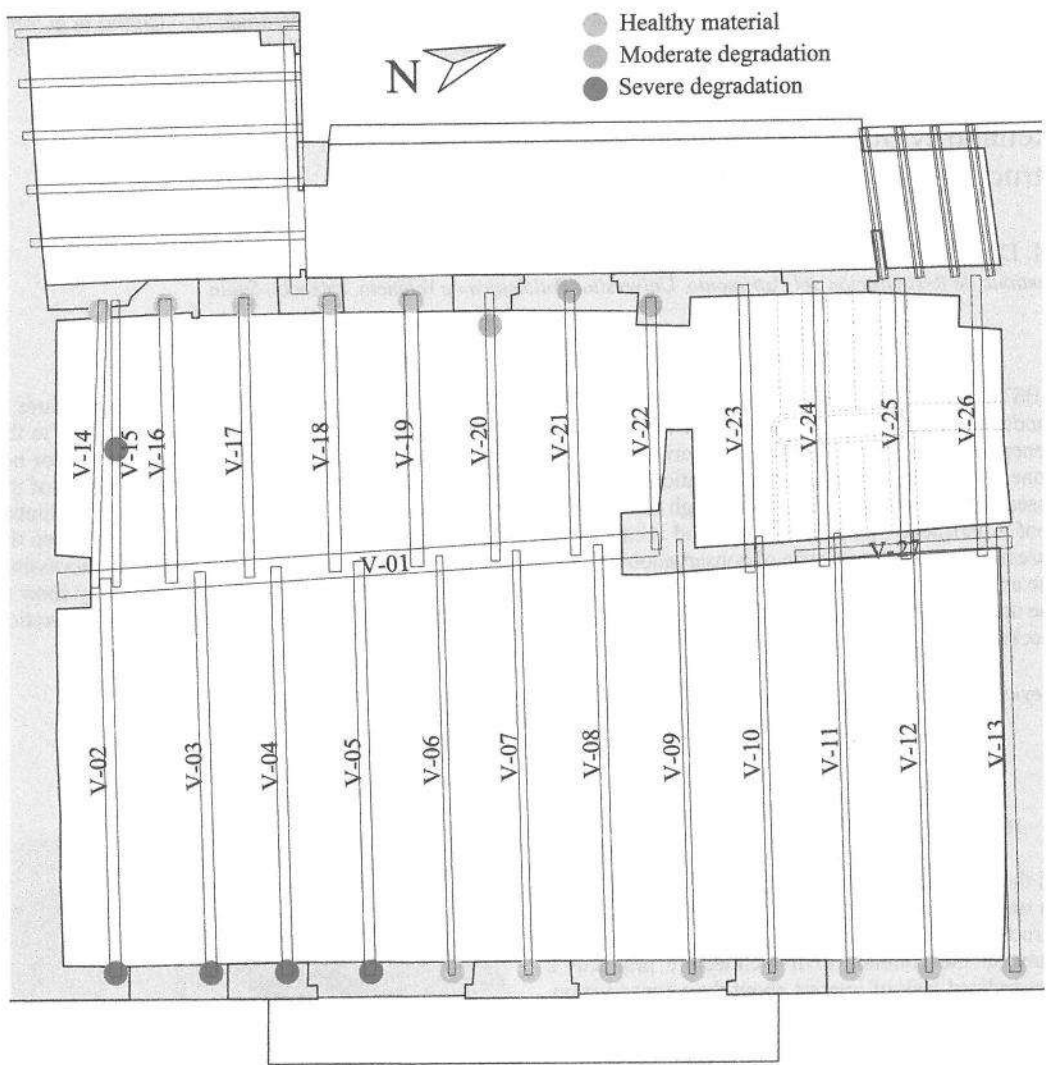
Figure 2. Plan of the roof with the codes of the timber elements studied.

As can be seen in Figure 2 the degradation seemed to be concentrated in two specific areas.

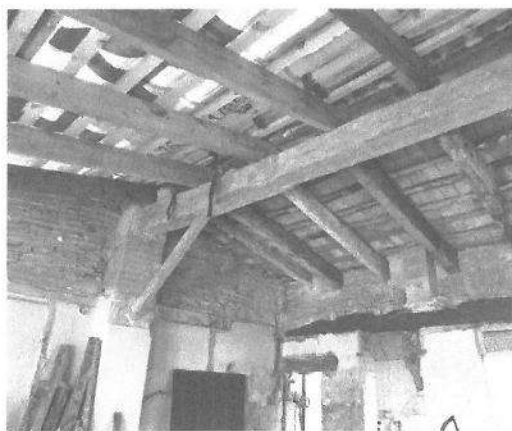
Figure 3. Roof structure.

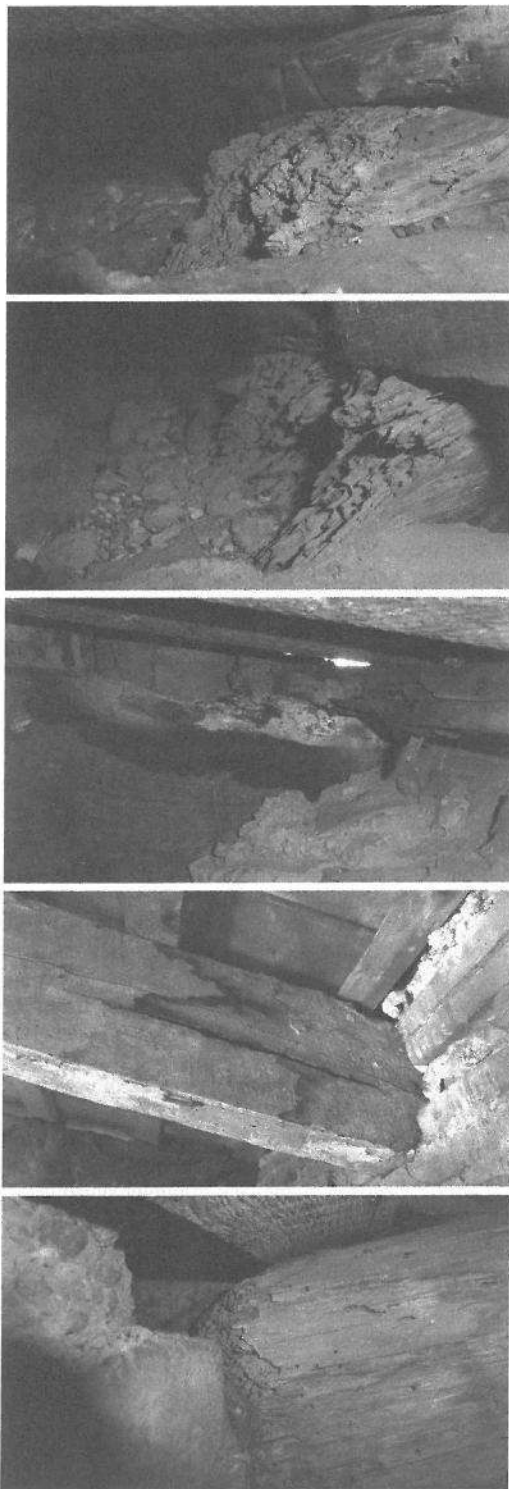
Figure 4. Rafters: V-02, V-03, V-13, V-20 and V-22.

Concerning the eastern rafters, the ends of V-02 to V-05 could be photographed and the damage made by the termites was clearly revealed (Fig. 4) however no insects were detected. Similarly, rafter V-13 was visibly affected by the infiltration of water due to the poor condition and execution of the roof. In all these cases the supporting area was greatly reduced.

In the case of rafters V-02 to V-05 and V-13 the visual assessment had a 100% of correspondence to the real damage. The rafters' ends had completely disappeared due to termites even if the attack was not active. It also seemed that the problem was amplified by the humidity caused by the integrated gutter that historically passed near the rafters' ends and that maybe caused also the degradation and former substitution of the rest of rafters in the same field of roof.

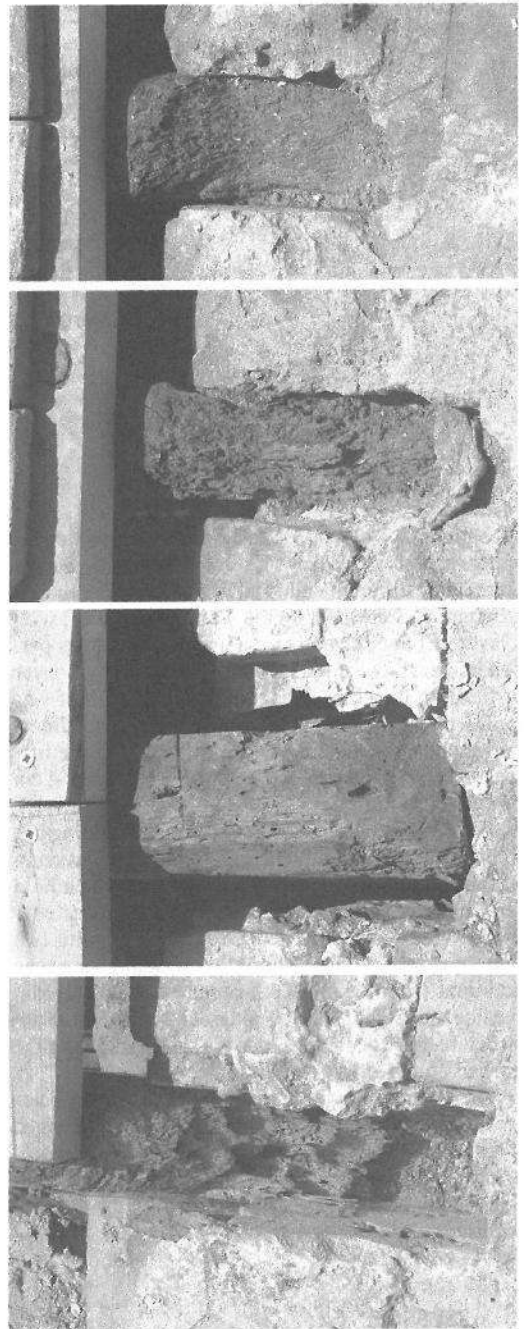
Figure 5. Rafters: V-19, V-20, V-21 and V-22.

Rafters V-20 to V-22 were considered with the same degree of degradation while, once revealed, they have different extent of decay (Fig. 5).

V-22 had a great damage similar to the eastern rafters that could just be glimpsed from outside. V-21 was in good health as the rafters V-16 to V-18. Finally V-20 had a moderate extent of damage that is similar to the one found in V-19 which however was not detected in the inspection.
