Restoration of Gothic Wooden Ceilings

Fernando Vegas¹, Camilla Mileto²

Abstract The church of Vallibona (Castellon, Spain) was built between the 13th and 14th centuries, with ashlar pointed arches supporting a wooden polychromatic ceiling and the gable tiled roof. At the end of 17th century, the church was converted into a Baroque temple, building a decorated barrel-vault inside the existing temple concealing the gothic wooden ceiling behind it. Moreover, at the beginning of 20th century, a new big chapel was added laterally to the North elevating the gable end of the church to cover the new whole. This involved dismantling the wooden ceiling of the northern gable and re-assembling it anyhow in disorder as an extension of the historical southern gable. This paper presents the detailed preliminary survey made on the wooden ceiling, the different options considered for the restoration and the first phase of repair already done that unveiled its original assembly system and the building site organization.

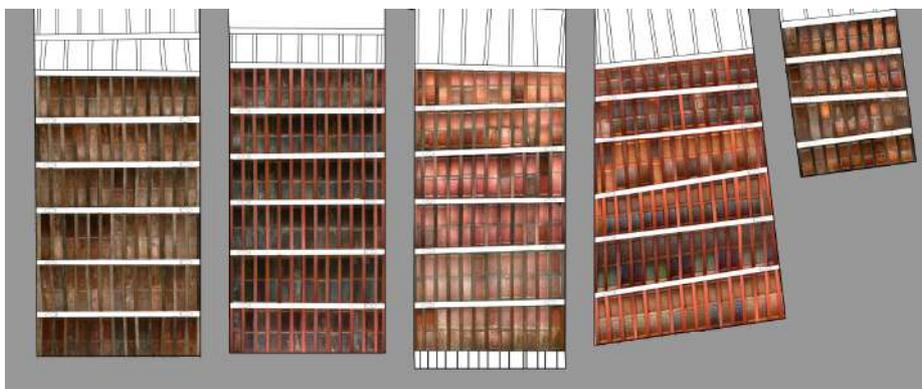
First of all, a very detailed survey has been made based upon orthophotography, that has helped to define the exact dimensions of the wooden pieces, its assembly, constructive details, painted decoration and current damages. Nearly 3.000 photographs have been taken of every painted face of each piece forming the Gothic wooden ceiling. All these photos have been afterwards graphically rectified in order to create metrical orthophotos to be inserted in the architectural survey. Hundreds of plans have been developed this way, forming a unique architectural, constructive and decorative documentation of the whole wooden ceiling and its current state, that present many leaks that are not only washing away the coloured paintings and exposing the wood to insects and fungus attacks, but also affecting very seriously the Baroque vault built with flat vaults bonded with gypsum and with a very complex decoration made of gypsum.

Figure 4 – The orthophotography of the Gothic wooden ceiling of the church

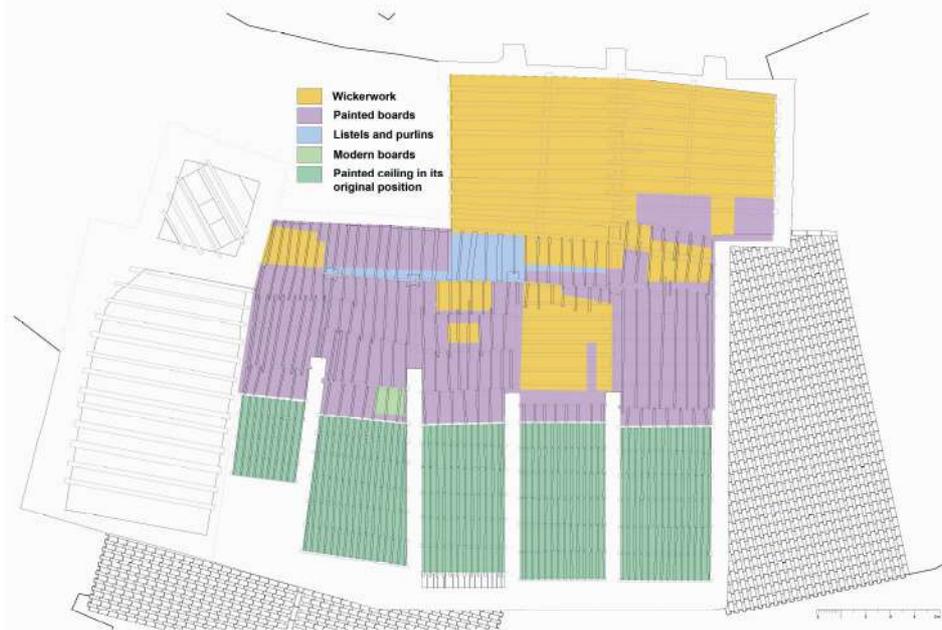
Figure 5 – The plan of the different types of ceiling of the church

Being objective, we could argue against the first option, i.e. leaving the relocated wooden pieces from the former northern gable in their present chaotic disorder, that many of them are upside down in touch with the tiles mortar or form part of the improvised floor under the roof, in both cases seriously jeopardizing the paintings. Being subjective, it is true that on the contrary to the original southern gable that is possible to restore in situ, the disordered relocating of the former northern gable with beams, purlins and boards out of the original rhythm does not help at all to restore them, at least, what regards the paintings. Dismantling the roof in order to have access to these pieces, restoring them and relocating them in their hazardous ubication or even upside down in touch with the tiles mortar, would be an absurd.

With all these arguments in hand, it was decided the third option, i.e. to tackle an in situ restoration of the original southern gable, dismount the relocated and disordered former northern gable to restore it in workshops and expose it afterwards. Before proceeding to repair the tiled roof, it was necessary to previously consolidate the paintings, because many of them were risking to peel off.

Thus the process for each ceiling sector would be following: consolidation of paintings from the interior in order to avoid losing them with the help of Japanese paper if necessary; dismantling of the tiles and piling them for reuse; eliminating the mortar and/or other layers till arriving to the extrados of the painted wooden boards; carefully dismantling of the wooden ceiling in the former northern gable nowadays placed in disorder as an extension of the southern gable numbering and classificating all the painted elements in order to be restored in workshops; building of new beams, purlins and listels following the existing constructive logics and rhythm in the original southern gable; treating all the wooden ceiling against insects and fungus; creating a ventilated and thermally isolated chamber on the wooden ceiling extrados and a second layer of phenolic boards sealed in their joints for improved waterproofing; putting again the original tiles; and finally, once eliminated all the leaks, restoration of the polychromatic wooden ceiling of the original southern gable in situ.

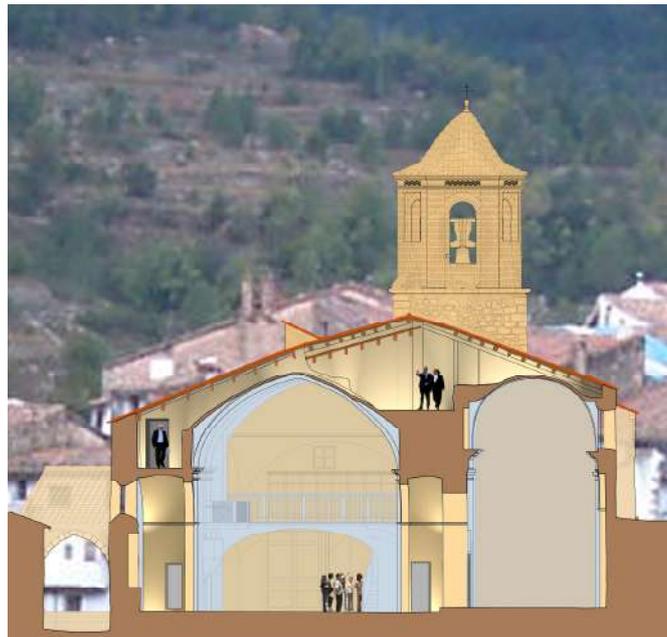
Figure 6 – The cross section of the project of the church of the Virgen de la Asunción

On the other hand, once restored in workshops, all the recovered pieces of the former northern gable would be remounted constructively in place, hanged at short distance from the new wooden ceiling in order to be exposed for the visitors in the big central space. It would be also possible to organize a perimeter course upon the Baroque vaults in order to be able to observe not only the relocated northern gable from the existing generous space under the roof, but also the southern gable in its original position.
