# Flood Risk Assessment of Traditional Adobe Buildings: Analysis of Case Studies in the River Ebro Basin, Spain

**Abstract.** Earthen masonry is a historic construction technique widespread in the river Ebro basin (Spain). These masonry walls are made of small earthen blocks, such as adobes [1]. Throughout history frequent floods of the river Ebro have threatened the integrity of earthen masonry construction. Due to climate change, this region is undergoing an increase in the severity and frequency of flood events, causing considerable losses to architectural heritage [2]. According to various studies, earth as a building material has hygroscopic characteristics which influence its resistance to water [3]. The devastating effects of flood events on historic structures due to changes in the interaction between subsoil and foundations include damage to the superstructure [4]. This research proposes a flood risk assessment methodology following a component-based modelling framework. The susceptibility to floods of the building components is evaluated, considering the material, structural and morphological characteristics [5]. The conservation state of the assets is also considered, a

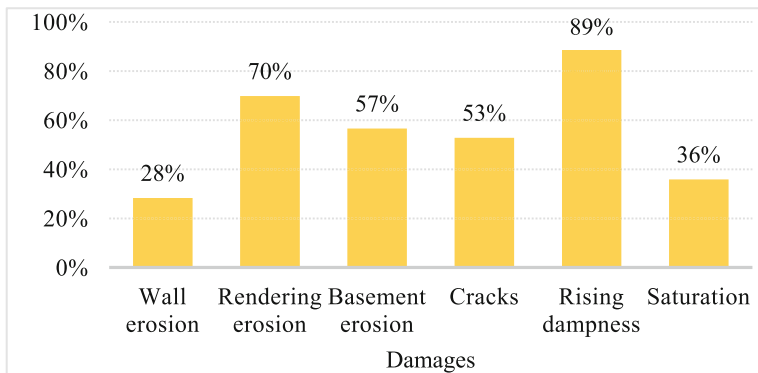
Some considerations can be made regarding the effects of floods and land structures based on the observation and analysis of the assets. Walls exhibit several types of deterioration resulting from the direct and indirect effects of flooding. The percentage distribution graph in Fig. 3 shows the presence of erosion and detachment of the rendering in many assets (Fig. 4a), possibly caused by rising damp and dry-wet cycles. Generally, rising damp is not considered an influential factor in flood damage assessment. However, Kelman and Spence [32] demonstrated its relevance, as it can trigger indirect damage. During a flood, materials are quick to reach complete saturation, giving rise to changes to their physical and mechanical properties.

**Fig. 3.** Percentage distribution of damage.

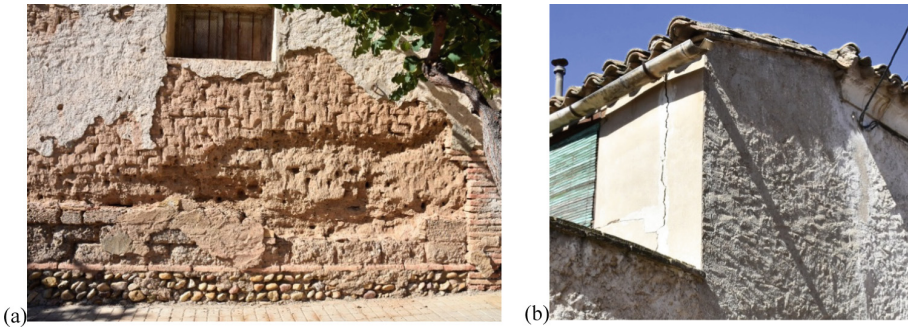
Long-term effects of flooding can lead to structural damage such as cracks and deformation. More than half of the assets analysed display vertical and parabolic cracks possibly caused by rotations and subsidence (Fig. 4b). According to Herle et al. [4], flooding affects the foundation soil, changing its hydraulic state. Thus, cracks and deformations appear in the superstructure due to the increase in the hydraulic gradient, causing soil erosion, subsidence, and damage to the foundations of the buildings. Moreover, the vertical and parabolic crack patterns depend on the lack of transverse connection between walls, which are free to rotate or move independently.

**Fig. 4.** (a) Wall and plinth erosion; (b) Vertical crack.
