Thinking about historic resources: A proposed guidance document

I.R. Stiegler & R. McManus

ICOMOS ISCEAH Sub-committee on In-Use, USA

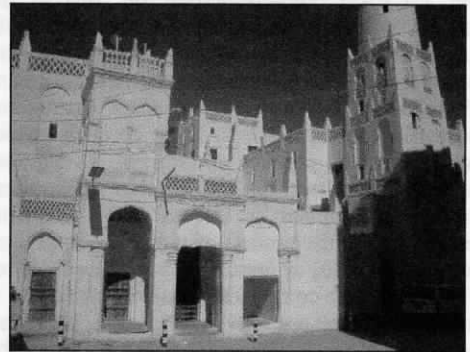
Figure 1. Southern view of Ribat Riyadh before the renovation. Courtesy of T. Leiermann.

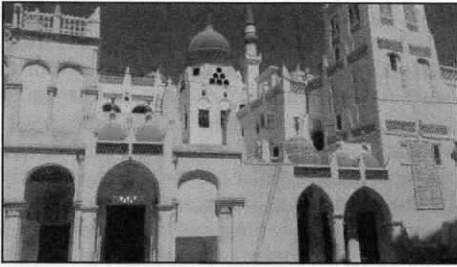
Figure 2. Southern view of Ribat Riyadh after the renovation. Courtesy of T. Leiermann.

Other parts of the building, however, underwent larger transformations and even destruction. The old ceiling, constructed of mud vaults and wooden beams, was replaced with a concrete ceiling. Wooden window lintels were replaced with concrete ones, which destroyed triangular lamp niches above the windows which were vital to the design of the interior. The proportions of arches and columns were changed, causing the integrity of the prayer hall to be lost.

In the ablution wing, traditional cisterns were changed into modern ablution cells with ceramic tiles. On the exterior of the building, plaster decoration was replaced without an understanding of the logic and intent of the original design. This led to shapes which are similar to the historic ones but which don’t reflect the essence of the historic design’s geometrical harmony. Therefore, the new

exterior plaster cannot serve as documentation of or a model for the traditional craftsmanship which is so important to the building.

In addition to the alteration or destruction of many historic features, the renovation included the construction of a second minaret and domes in Egyptian and Turkish styles. These changes turned a building of an already unusually high level of ornamentation into a collection of historic and pseudo-historic details.

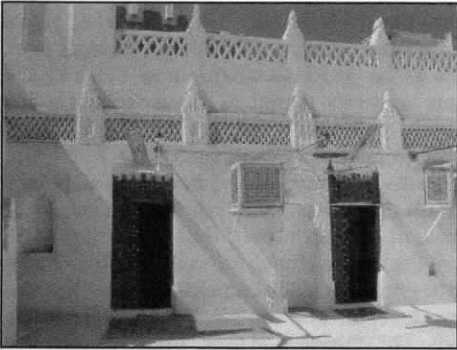
Figure 3. Courtyard entrance before the renovation. Courtesy of T. Leiermann.

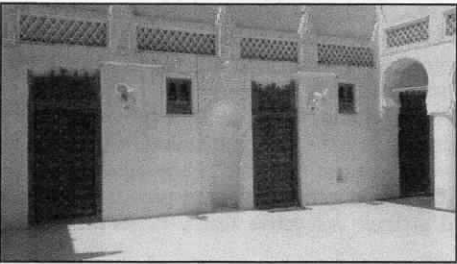
Figure 4. Courtyard entrance after the renovation. Courtesy of T. Leiermann.

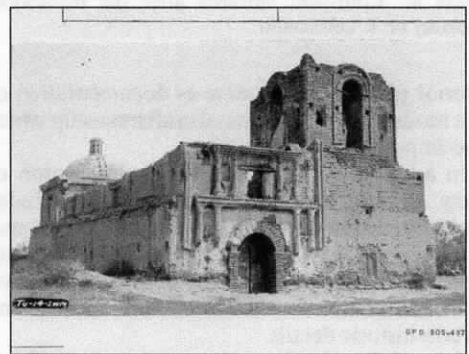
Figure 5. Tumacácori in 1919. Photograph in the public domain, courtesy of the NPS.

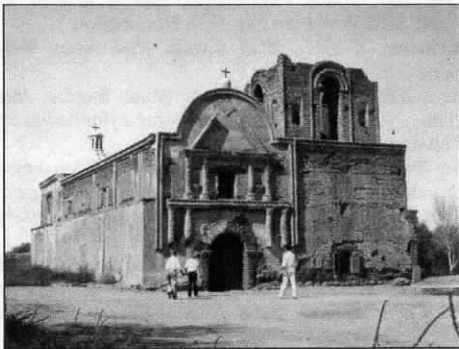
Figure 6. Tumacácori in 1938, following a major reconstruction effort. 1935 was the first year that an experimental chemical consolidant was used on the walls. Photograph in the public domain, courtesy of the NPS.

In addition, Tumacácori became a lab for a number of experimental or relatively untried chemical consolidation techniques. Chemical consolidants were first utilized on the deteriorating adobe walls in 1935 and were used liberally throughout the 1950s and 1960s. According to a 1985 Historic Structure Report, "a silicone material, 'Daracone,' was used by Gordon Vivian in the mid-1950s and Roland Richert began to experiment with 'Daraweld' in 1960. Daraweld was apparently used periodically during the 1960s and perhaps into 1970-71" (Crosby 1985). A 2010 news article indicates that these experimental preservation methods were ultimately not compatible with the adobe bricks and lime plaster of the walls and resulted in internal erosion to "such a degree that they became little more than hollow shells" (Brocius 2010).

tested and reliable treatment methods. The silicone-based consolidants used beginning in the 1930s did not allow the adobe to 'breathe' and, since the intervention was not reversible, caused severe and continued damage to the walls. The extensive reconstruction of non-extant features completed before the 1970s does not reflect the current preference for minimal intervention. And, finally, the widespread and repeated use of experimental methods of treatment is never advisable unless all other options have been deemed insufficient.

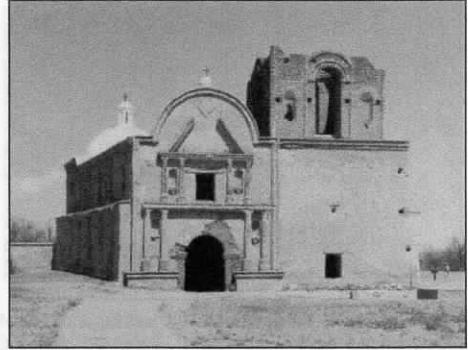
Figure 7. Tumacácori in 1970, following decades of reconstruction and chemical consolidation. Photograph in the public domain, courtesy of the NPS.

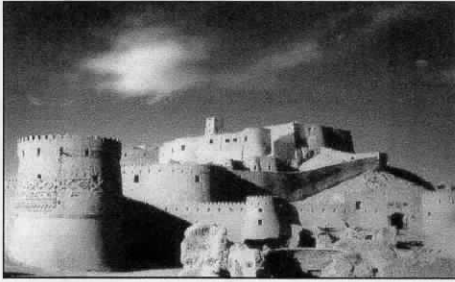
Figure 8. Arg-el-Bam before the earthquake. Photograph by Arad Mojtahedi (2000). Licensed under CC BY-SA 3.0.

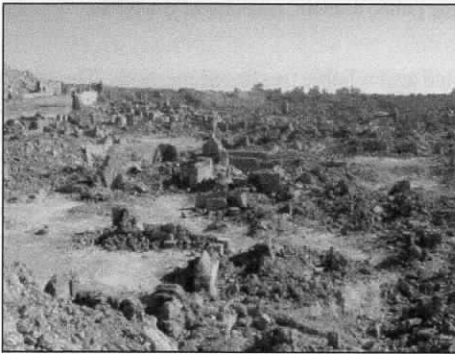
Figure 9. Arg-el-Bam after the earthquake. Photograph by the US Federal Emergency Management Agency (public domain).

The 2003 earthquake illuminated a crucial flaw in the previous decades of otherwise successful restoration: the restorers did not have the foresight to seismically strengthen any structures that were restored. This oversight is especially egregious considering the region's long history of significant seismic activity, and as a result the city suffered the loss of nearly 70% of their mud brick buildings (Manafpour 7).

The unfortunate destruction of Arg-e Bam may not have been completely avoidable, but seismic retrofitting of historic buildings has been shown repeatedly to successfully protect earthen architecture against structural collapse in the event of an earthquake. In this case, an otherwise appropriate restoration effort was undercut by a failure to prioritize structural stability before undertaking any further interventions in the complex. Structural interventions are not always visible or exciting but can assure the survival of historic fabric and any additional interventions at the site. The case of Arg-e Bam also illustrates the necessity for a comprehensive evaluation of threats to a resource and the necessity of a treatment plan that mitigates as many of those threats as possible.
