Constructive analysis of the rammed earth walls in the Petrés castle (Valencia, Spain)

Constructive analysis of the rammed earth walls in the Petrés Castle (Valencia, Spain)

F. Vegas López-Manzanares, C. Mileto, F.J. Gómez-Patrocinio & A. Pérez Vila

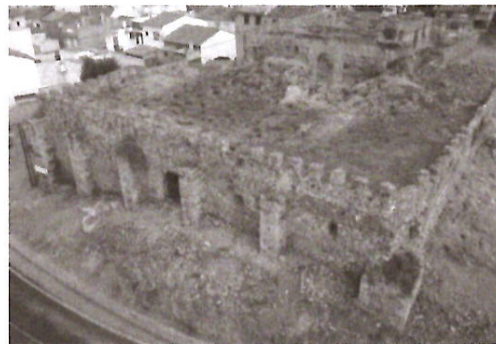
Figure 1. General view of the Castle of Aguiló in Petrés, Valencia (P. Rodríguez Navarro).

The castle, made up of two volumes with a rectangular floorplan, is located on a small promontory overlooking the town of Petrés (Fig. 1). This site approximately 30 km North of Valencia was probably originated as a Moorish rural settlement belonging to the city of Sagunto, and its designation as a municipality in the mid-fourteenth century is closely linked to the construction of Aguiló Castle (Corresa 2016).

The castle in Petrés is made up of two very different volumes, yet both were built mainly using earthen formwork elements (Fig. 1).

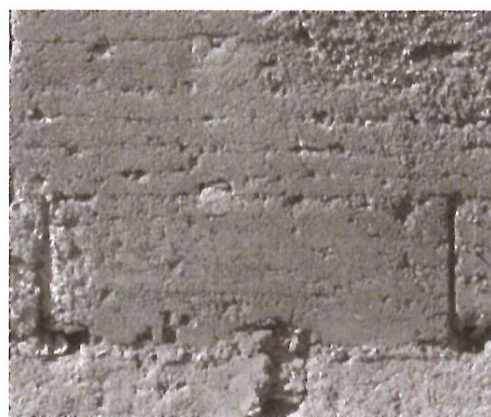
Figure 3. Detail of the north facade of the upper volume (Authors).

Petrés Castle is a highly heterogeneous building given that different techniques were used in the execution of its different spaces, even when completing similar elements within a single body. However, the use of a poured mass of earth, lime, and stone as a basic material is a constant in the construction of most of the elements (Fig. 3).

The imprints left by the auxiliary devices on the castle walls during construction suggest something akin to rammed earth construction (See 3.2 *Constructive techniques*). However, the number of large pebbles on the walls must have hindered the manual tamping of the material poured in, and as can be seen from the marks on the walls, the layers applied were thicker than those usually seen in rammed earth construction: 18 cm instead of the 10 cm considered suitable for compacting (López Martínez 1999).

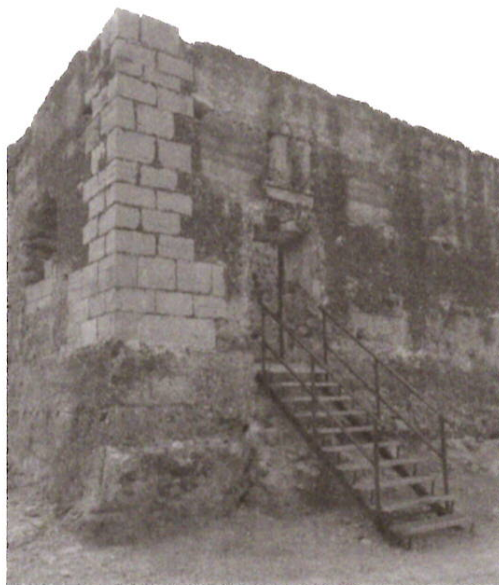
Figure 4. Meeting of two external perimeter walls of the castle, finished off with ashlar of *pedra blava de Morvedre* on the corner (Authors).

In the walls of the upper volume of the castle, both the outer corners and openings from the first construction period of the building were built using an ashlar construction of *pedra blava de Morvedre* which became part of the lime and earth concrete formwork at the pouring stage (Fig. 4).

The corners in ashlar are made up of two stone sheets 30 cm thick, and the outer sheet is of better quality than the inner one. A lime and large pebble mix similar to Roman concrete was poured
