Studies for the restoration of the Islamic Bofilla Tower as an example of wood use in rammed earth structures

C. Mileto^{a,*}, F. Vegas^a, V. Cristini^a, N. Macchioni^b, L. Sozzi^b, S. Lazzeri^b

^a Universitat Politècnica de Valencia, Cno. Vera s/n, 46022 Valencia, Spain

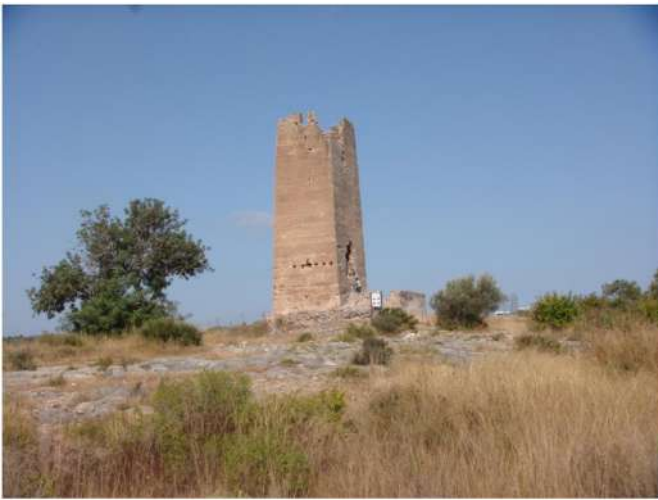
Fig. 1. Bofilla Tower before the conservation work (C. Mileto and F. Vegas).

The Bofilla Tower in Bétera (Valencia) (Fig. 1), near the Spanish Mediterranean coast, is a defensive rammed earth structure erected in the Moorish era in the early 13th century (Bazzana and Guichard, 1978). Together with about forty similar structures, associated with farms, it is part of the protection and sighting system around the city of Valencia during the years of the Christian re-conquest (Rodríguez, 2008). Progressively abandoned in the 15th century, due to wars with the kingdom of Castile, famine and plague epidemics (López Elum,

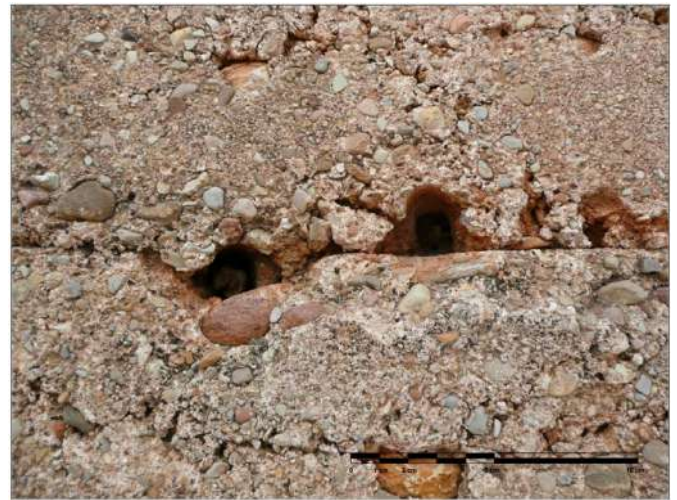
Fig. 3. Putlogs of the formwork inside the walls of Bofilla Tower (C. Mileto and F. Vegas).

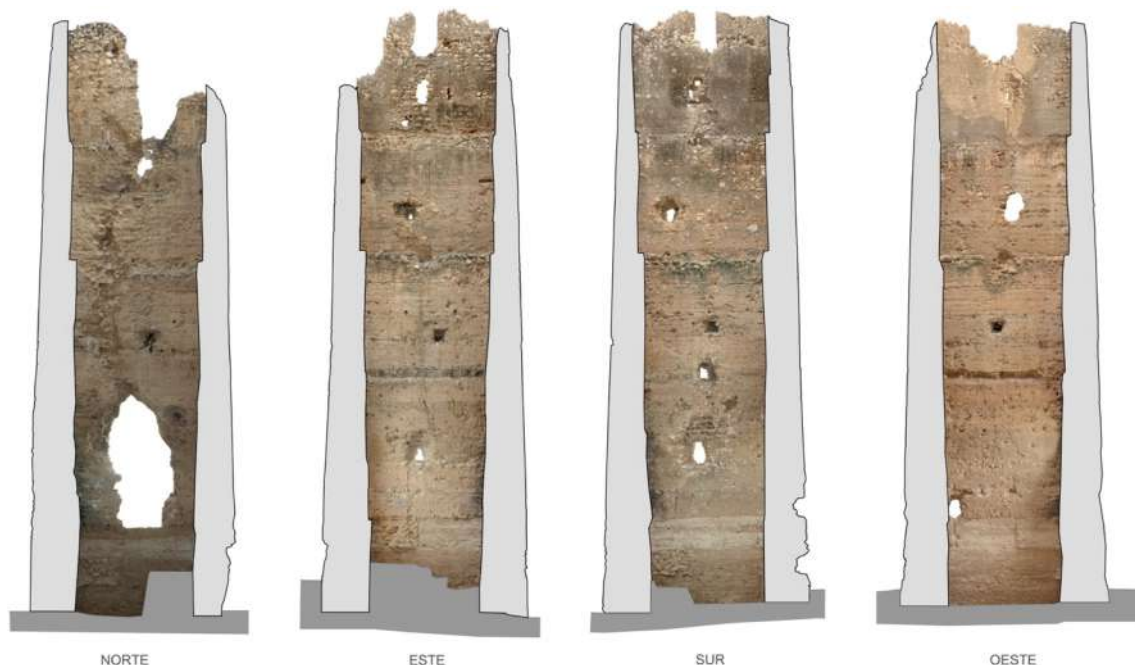
Fig. 2. Bofilla Tower, inner sections, before the conservation work (C. Mileto and F. Vegas).

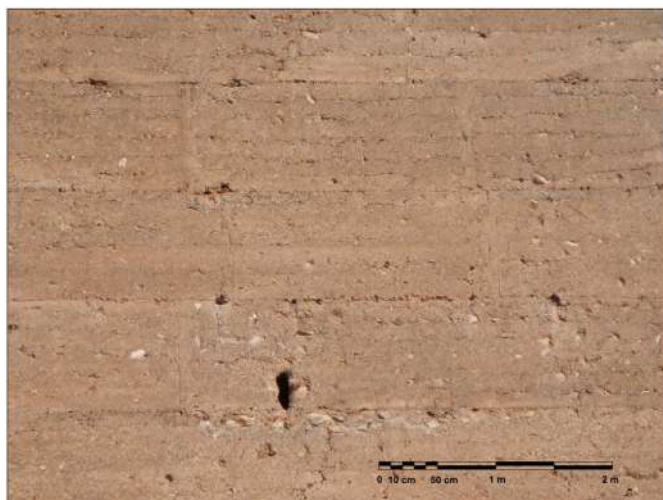
Fig. 4. Imprints of formwork in walls of the Bofilla Tower (C. Mileto and F. Vegas).

Moorish residents on an existing farm, considering the simplicity, local materials, and the domestic formwork employed, similar to those used in the farmhouses, as established by the archaeological excavation. These assumptions are confirmed by the numerous imprints of the formwork which are still visible on the surfaces of the building, which is made up of 21 rammed earth courses, each with a height of between 83 and 92 cm, totalling 18 m in height. The materials used for the walls, which can be found near the tower and the neighbouring torrent of Carraixet, primarily consist of earth with natural aggregates (90%), lime (10%) and rough stones (approx. 15 × 30 cm) used as reinforcement in regular layers inside the formwork (Kroner et al., 2009).

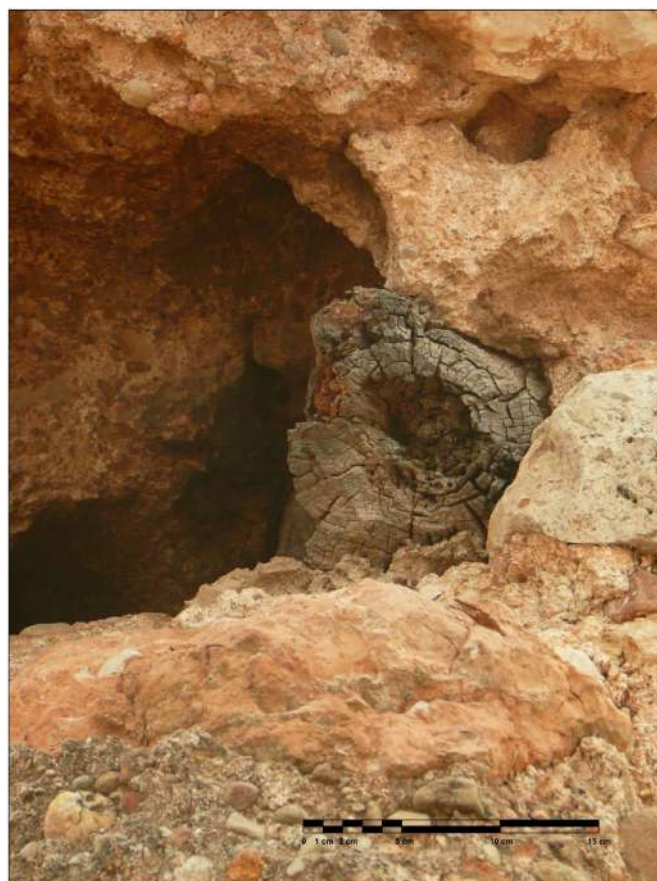
Fig. 5. An example of wooden sleepers in the corner of the northwest wall (V. Cristini).

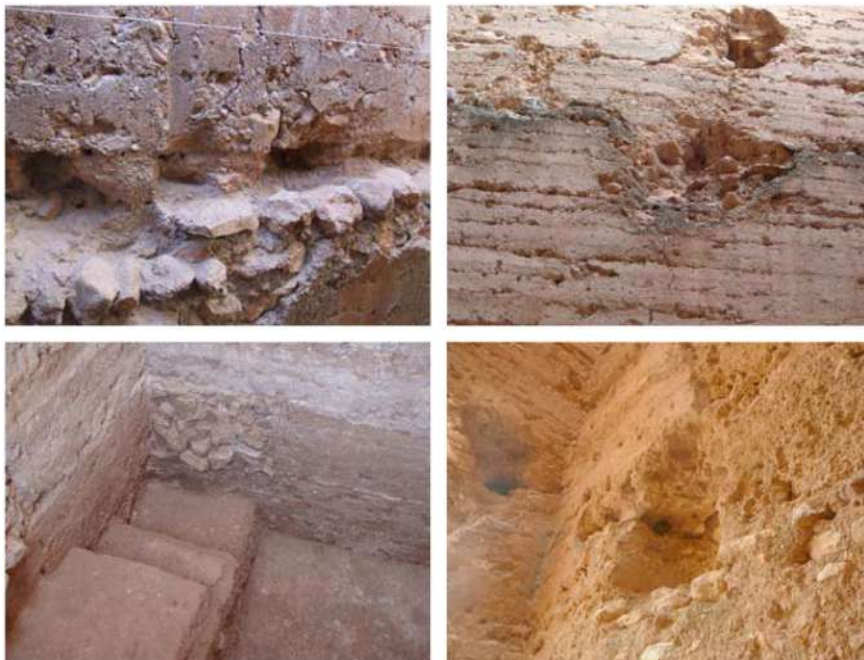
Fig. 7. Study of the imprints that the original floors left on the internal walls of the tower. It has been possible to understand the location of the girders and joists in every floor and the place where the ladders were placed (C. Mileto and F. Vegas).

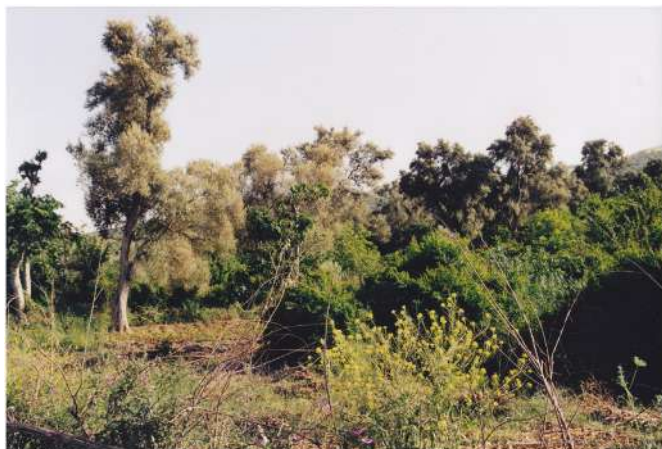
Fig. 13. Tall olive trees near Fez in Morocco. Similar trees were possibly used to obtain the beams for the Bofilla Tower.

some forms of productive activities led to the development of very tall trees and a less dense distribution of plants compared with current standards of olive monocultures; a good example of this is the picture in Fig. 13 showing tall olive trees in the countryside near Fez, in Morocco. For this reason, the logs used in the construction of the tower are not limited to the normal length of today's trees, as the trunks

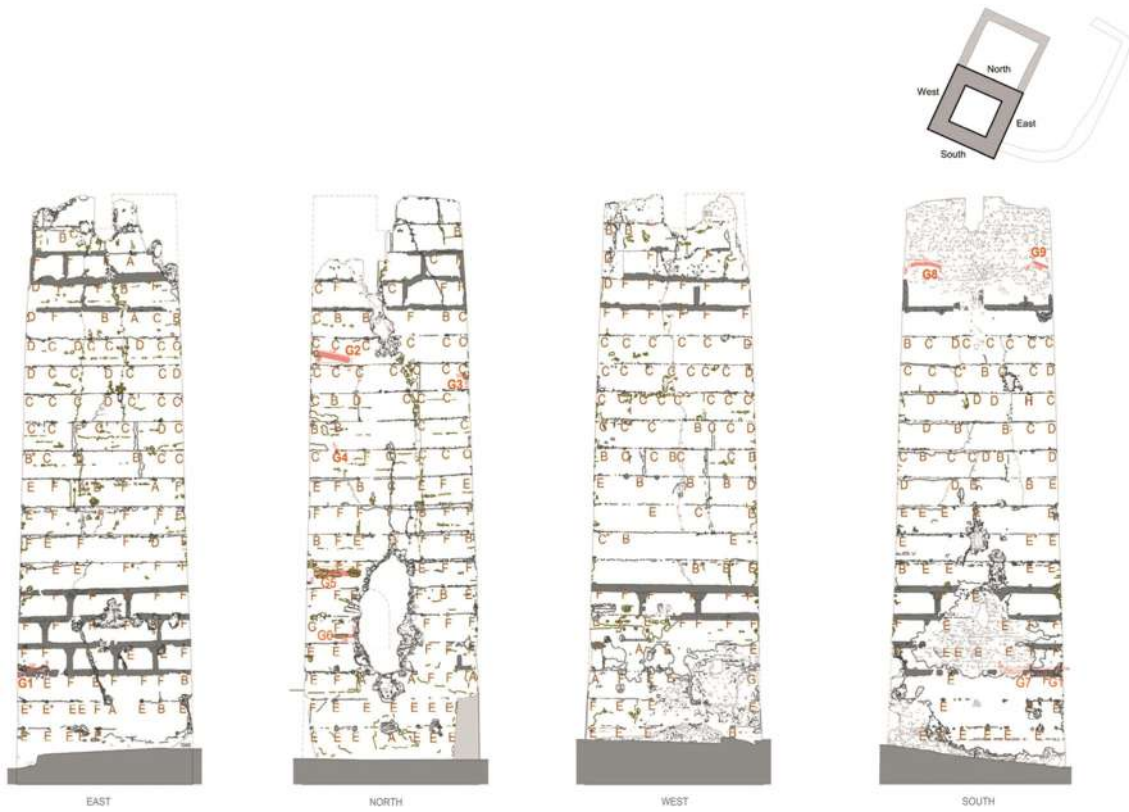
Fig. 15. Mapping of the wooden putlogs and the reinforcement in the walls of the Bofilla Tower (C. Mileto and F. Vegas).

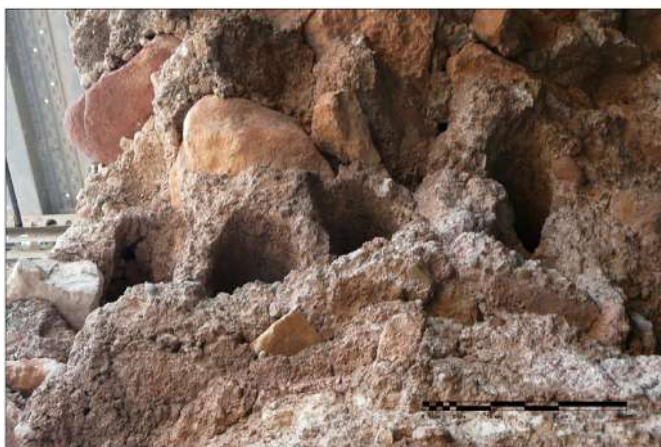
Fig. 18. Imprints of the reinforcement logs for the lintel of the access room (V. Cristini).

The Bofilla Tower shows interesting wooden reinforcement systems, identifiable within the structure. Indeed, as frequently occurs in cases of Islamic defensive architecture, the corners of the walls are made up of continuous modules of rammed earth, which are crucial points for the strategic function and stability of the building. In these areas, thanks to the presence of erosion in the facings, at least 9 sleepers, rough beams, designed to reinforce the angles (Fig. 17), were located. Other wooden logs are embedded in the walls, in this case visible in the access area. The arched doorway of the tower itself was reinforced with a lintel, made of four olive trunks about 14 cm in diameter, whose imprints were perfectly identifiable during the restoration process (Fig. 18).

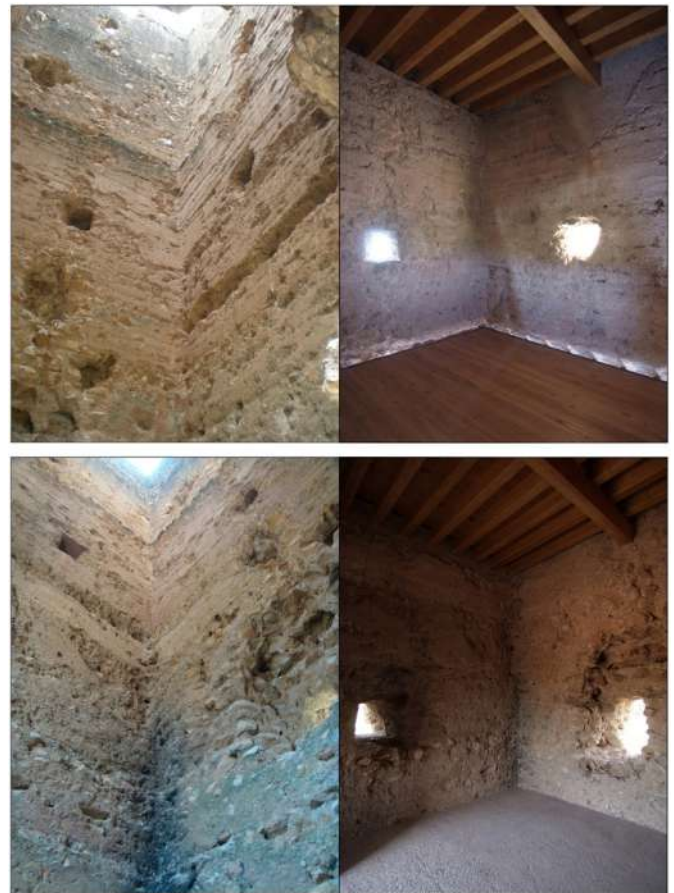
Fig. 21. New floor project, respecting the imprints of original planks (C. Mileto and F. Vegas and T. Baeza).

In addition to these considerations with respect to the type of wood to be used, the construction of the new structures tried to follow the traces of the measurements and position of the original missing elements, still identifiable in the imprints in the rammed earth wall. The new solid pine wood boards only lean against the original walls, ensuring compliance with the initial finishes and correct access to all levels of the tower at the same time. Whilst respecting the grooves and rhythm tracks of the original floors, it was decided to finish them off with wooden profiles, using contemporary building practice and standard profiles. The floor is made of wooden beams (12×18 cm) and rafters (9×12 cm), carefully inserted into the original positions without modifying the structure, with a 5 cm thick processed plank set in a metal profile and set back from the inside edge of the wall (Fig. 21). Plywood beams and rafters have been put in place with three vertical slats, thus improving control of bending and torsion without sacrificing the simple appearance of the natural beams.

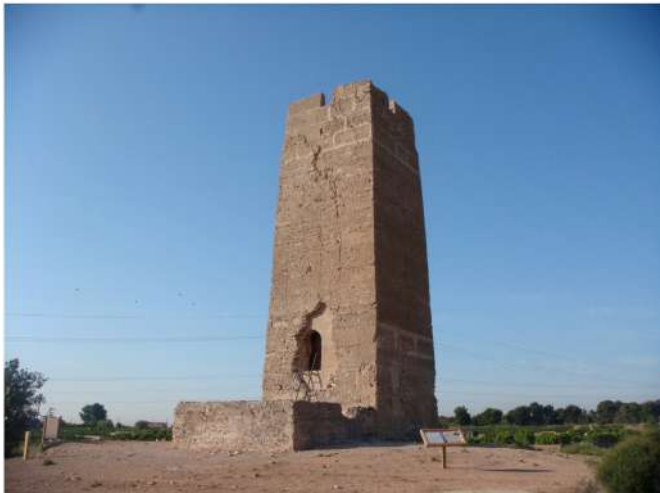
Fig. 20. Bofilla Tower after restoration (C. Mileto and F. Vegas).

The restoration (Mileto and Vegas, 2012) of the Bofilla Tower has aimed to preserve all imprints resulting from its construction process and the passage of time (Fig. 20). During the restoration and
