# Flood Risk Assessment of Traditional Adobe Buildings: Analysis of Case Studies in the River Ebro Basin, Spain

**Abstract.** Earthen masonry is a historic construction technique widespread in the river Ebro basin (Spain). These masonry walls are made of small earthen blocks, such as adobes [1]. Throughout history frequent floods of the river Ebro have threatened the integrity of earthen masonry construction. Due to climate change, this region is undergoing an increase in the severity and frequency of flood events, causing considerable losses to architectural heritage [2]. According to various studies, earth as a building material has hygroscopic characteristics which influence its resistance to water [3]. The devastating effects of flood events on historic structures due to changes in the interaction between subsoil and foundations include damage to the superstructure [4]. This research proposes a flood risk assessment methodology following a component-based modelling framework. The susceptibility to floods of the building components is evaluated, considering the material, structural and morphological characteristics [5]. The conservation state of the assets is also considered, a

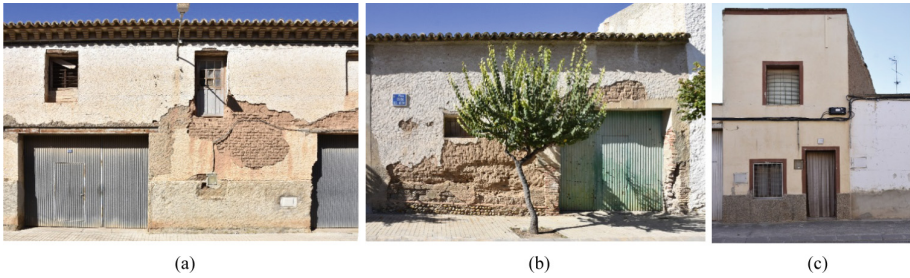
The risk assessment approach proposed in this study has been applied to 53 adobe buildings, 38 of which are in Torres de Berellén and 15 in Boquiñeni (Fig. 2). These residential buildings are between 3 and 8 m high (one to three-story buildings). Generally, only the upper floors are used as a dwelling, while the ground floor is used for storage. All these assets are built with adobe walls 40 to 60 cm deep resting on brick plinths. On average the adobe blocks measure  $17.5 \times 7.5$  cm, with 2 cm mortar joints.

**Fig. 2.** (a) Two-story adobe building in Torres de Berellén; (b) Single-story adobe building in Torres de Berellén; (c) Two-story adobe building in Boquiñeni.

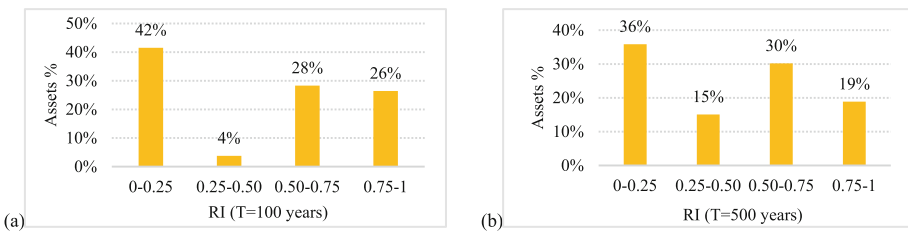
For the 10-year return period, results were nil and omitted, as water does not affect the assets. Figure 5 shows the RI percentage distribution corresponding to 100- and 500-year return periods. A comparison of the graphs in Fig. 5 reflects a significant variation. The percentage distribution graph for the 500-year return period shows an increase of 9% and 2% in assets with RI values between 0.25–0.50 and 0.50–0.75, respectively. This variation is due to increased water depths for the 500-year return period hazard map.

**Fig. 5.** (a) Percentage distribution graph of the RI values for a return period of 100 years. (b) Percentage distribution graph of the RI values for a return period of 500 years

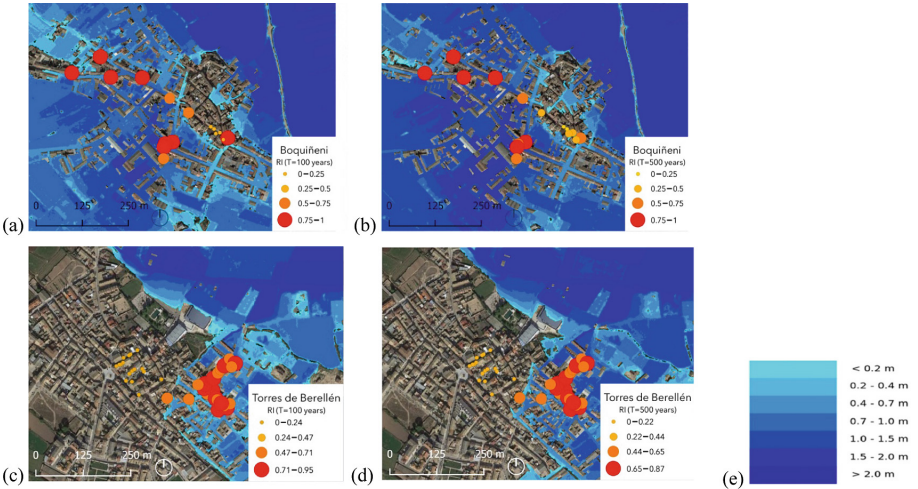
Figure 6 represents the spatial distribution of the elements at risk for the considered return periods. The assets in Boquiñeni are more exposed to floods than those in Torres de Berellén as the potentially floodable area is larger.

**Fig. 6.** Maps of RI values for earthen architecture exposed to fluvial flooding: (a) Boquiñeni, T = 100 years; (b) Boquiñeni, T = 500 years; (c) Torres de Berellén, T = 100 years; (d) Torres de Berellén T = 500 years; (e) water depth key.
